## Inspection Report

### The Estate of Janet H. Gourley

52 Whipple Road  
Kittery, Maine 03904

### DBC Home Inspections

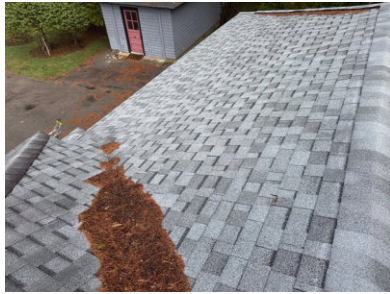
1.0 Item 1 (Picture)

A MIXED BAG OF TYPES AND AGES: The inspected property had three different types of asphalt roofing installed. Each type of roofing material also appeared to be a different age and displayed different characteristics and conditions.

- Some portions of the house have low slope or flat roofing. These areas have a rolled asphalt roofing material. This material typically has a reliable service life of approximately 15 years. Evidence of wear and minor cracking was observed in multiple areas. These characteristics would indicate that the roofing material is around 15 years old.

- The bulk of the roof structure has a 3-Tab asphalt roof roofing shingle installed. Similar to the rolled roofing material, this style of shingle typically has reliable service life of approximately 15 to 20 years. Entirely depends on the quality of the initial shingle and the environment in which it is installed. At the time of inspection, the shingles generally looked to still be in serviceable condition, but there was evidence of age as well as organic buildup and material in multiple areas. Removal of any moss or other organics is highly recommended. Given the expected age of the shingles, age replacement will likely become necessary in the near future.

- A small portion of the roof appears to have an architectural style shingle that may have recently been installed. This roofing material typically has a reliable service life of approximately 25 to 30 years. These shingles appeared young and in good condition.

Generally, there were no indications of active leaking, observed on the interior of the home. That's it, given the apparent age of most of the roof covering, preparing for replacement is highly recommended. It would

be prudent to have a roofing professional, evaluate the roof area now and provide the client with estimates for replacement. Utilizing architectural style shingles would likely be recommended in pitched areas.

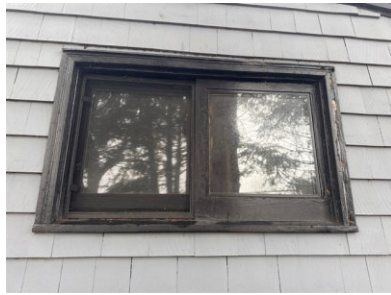
2.0 Item 1 (Picture)

(1) **TRIM TLC:** As is typical of most homes of this era, the trim is painted wood. To ensure a continued reliable life of the wood material, the paint coating on the trim should be maintained and sections where peeling and popping occurs should be sealed promptly to reduce the chance of rot. In any instance where wooden trim needs to be replaced because of rot or decay, I highly encourage replacing the wooden material with solid PVC trim (such as Kleer or Azeck). Once it is painted it nearly indistinguishable from

wood. Additionally, many of the classic exterior architectural details have been reproduced out of the same PVC material. During the inspection, it was noted that most of the older trim appeared in serviceable condition but some of the more modern trim around the apartments windows was displaying signs of decay and calls for replacement. See pictures for further details and obtain estimates for needed repairs prior to closing.

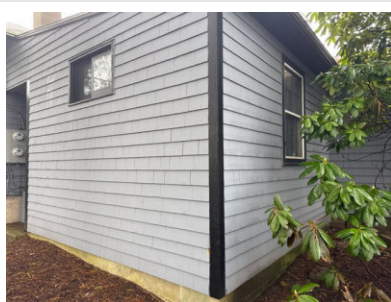
2.0 Item 5 (Picture)

(2) **PAINTED SHINGLES:** The home's shingle siding appeared to have been painted. As with many homes with painted siding, flaking paint will be a concern in the future. As older original layers of paint begin to release they will flake the new layers of paint off. Maintaining a complete paint coverage over all wooden siding materials is imperative in keeping the exterior of the house healthy. Over time some shingles, especially south facing areas, will show signs of cupping and cracking. Monitor these areas closely and repair any shingles that fail or fall apart.

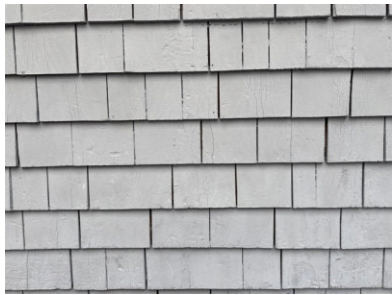
2.0 Item 14 (Picture)

(3) **LEAD PAINT CAUTION:** As is typical with a home this age, the siding and trim are showing signs of age and multiple layers of paint. Given the age of the home, the chances of there being a layer of lead based paint on the exterior is highly likely. Further evaluation and testing maybe prudent and desired to determine the presence of lead. Generally, the siding and trim was in fair condition with no immediate required. That said, like with every old home maintenance will be a constant. If lead is determined to be present, certain protocols will be required for future maintenance and repairs. It is strongly recommended to have a follow up evaluation with a properly credentialed [Lead Risk Assessor](#) prior to closing.

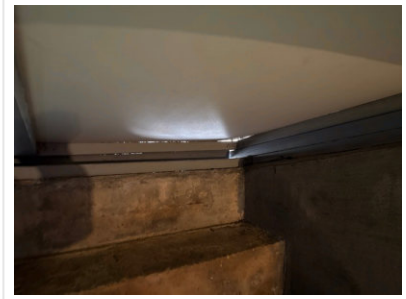
2.1 Item 6 (Picture)

(2) **BUTTON UP:** The bulkhead door provides access to the basement from the exterior. While these doors are very convenient they can be a source of heat loss. Unfortunately, there were several large air gaps that will allow cold air and pests to enter freely. I recommend a capable carpenter properly finish these areas so that there is a good air seal and adequate deterrents for pests and vermin.

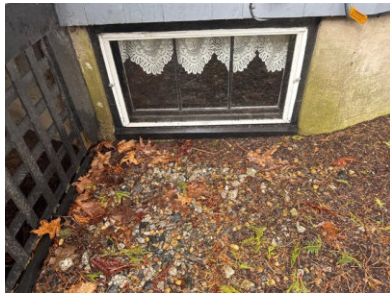
2.2 Item 1 (Picture)

(1) **AT GRADE:** At the time of inspection, the home had one, or more, grade level basement windows which were at, or close to, grade. The condition of the windows appeared good; but, as the windows are at grade there is room for improvement. I recommend digging out the area 6-10" or so and installing a simple window

well (with crushed stone is advisable). This would be a great improvement and could prevent water intrusion. Install as desired.

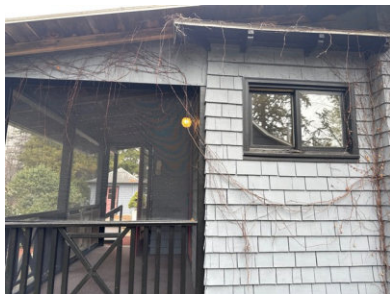
2.2 Item 3 (Picture)

(2) **DAMAGED WINDOW:** The pictured window on the south side of the home appears to have components, which have been melted. As one can see in the image, it is directly across from another house. Reflected light may have been the cause. Regardless of the cause, the damage could result in water penetration so a repair is recommended. Follow up with a capable contractor and repair is needed.

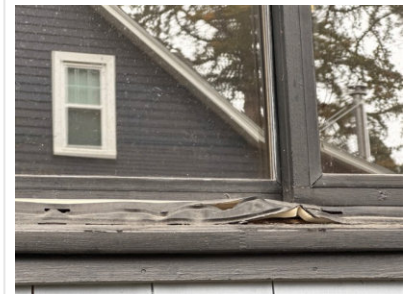
2.2 Item 5 (Picture)

(3) **WOOD SINGLE PANE WINDOWS:** Some of the windows in the home appear to still be original. They are single pane glass with storm windows installed. All appeared in good working order from the exterior. Function will be inspected & commented on in the "Rooms" Section of this report. Similar to other exterior components, these windows will need maintenance. The glazing compound will need periodic repairs and painting will be necessary. Insuring that the storm windows are closed during winter months will greatly assist in lowering the maintenance needs as well as fuel costs. Restore and maintain as needed.

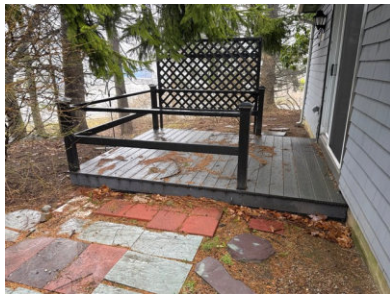
2.3 Item 1 (Picture)

**GROUND LEVEL DECK:** The pictured deck is built at, or on, ground level. As a result, a complete inspection of the structure was not possible. During the inspection the deck appeared solid; but, further evaluation is

not possible at this time. Monitor and repair as needed.

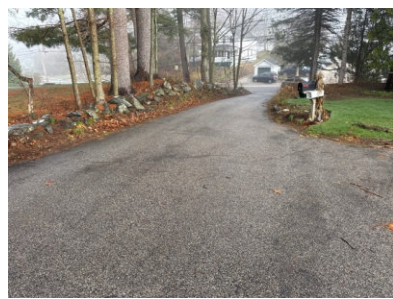
2.5 Item 1 (Picture)

(1) **DRIVEWAY:** Asphalt paving lasts the longest and holds up well to adverse conditions, compared with

**OBSERVED CONDITIONS:** The condition of the driveway was good. There was minimal cracking, no weeds growing through the asphalt. Having any cracks tarred and the entire driveway sealed next spring would be a great maintenance task.

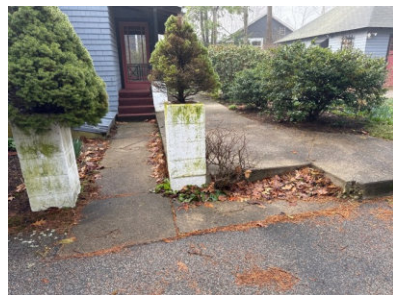
2.5 Item 4 (Picture)

(2) **SIDEALKS:** Sidewalks around the driveway garden appeared in serviceable condition. Evidence of minor settling was noted but there did not appear to be any calls for immediate action.

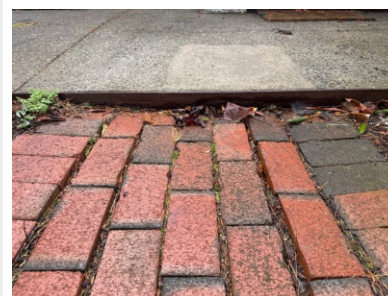
2.5 Item 10 (Picture)

(3) **BRICK PATH:** The brick path across the garden appears to have settled since installation and trip hazards are present. I recommend that a landscape professional evaluate and provide estimates for resetting the path.

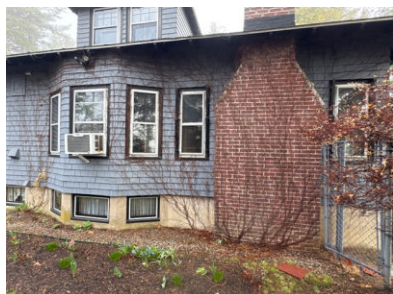
2.5 Item 11 (Picture)

(4) **VEGETATION:** Having vegetation growing on or too close to the home is not recommended. It can allow insects and vermin easy access to the home as well as cause significant rot. I would recommend vigilant pruning, cutting back and possibly removing the offending vegetation around the home.

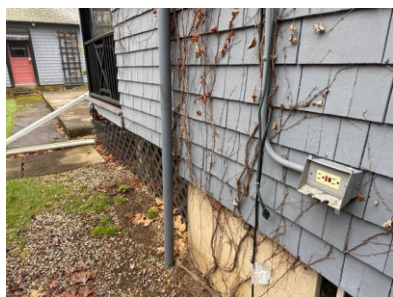
2.8 Item 1 (Picture)

**LOOSE PLATE:** The pictured outlet, on the side of the home, has a loose cover plate and needs repair. This issue should be repaired by a capable person or a licensed and insured electrician.

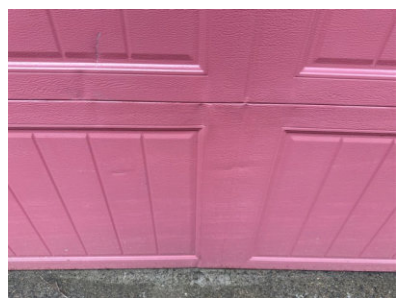
3.3 Item 1 (Picture)

**DENTS & DINGS:** The installed garage door did have some cosmetic dents and dings but they do not effect the door's operation. Repair as desired.

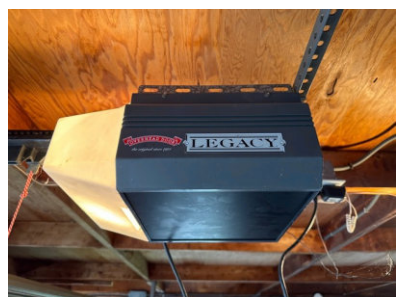
3.5 Item 1 (Picture)

**SAFETY ISSUE:** The garage door did not reverse when met with resistance. There were door sensors installed that did work. I would recommend a capable person or garage door professional adjust the operators setting to reverse under less resistance.

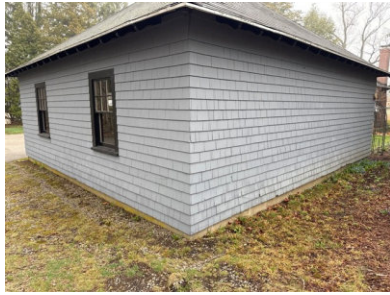
3.9 Item 1 (Picture)

**PAINTED SIDING:** As with every old structure the trim and siding is painted wood. To ensure a continued reliable life the paint job of the trim & siding should be maintained and sections where peeling and popping occurs should be sealed promptly to reduce the chance of rot. Overtime components of the trim will need to be replaced, when that time comes I encourage you to replace the wood rot with solid PVC (will not rot). The siding material may develop areas of rot over time as well. Areas of siding that are showing signs of rot should be treated promptly so that the rot does not spread to structure. Being vigilant about siding maintenance can lead to a long reliable life for the exterior of a home. The exterior appeared in serviceable condition.. Monitor and repair as needed.

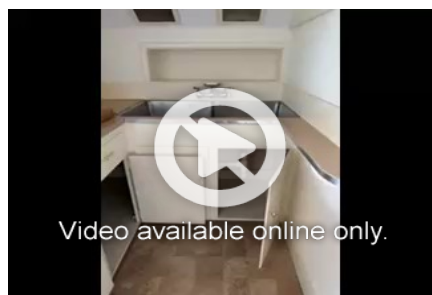
4.1.A Item 1 (Video)

**VENTING ISSUE:** The sink on the second floor made a gurgling sound when draining. This is often an indication of poor venting. A licensed and insured plumber should be able to repair with AAV.

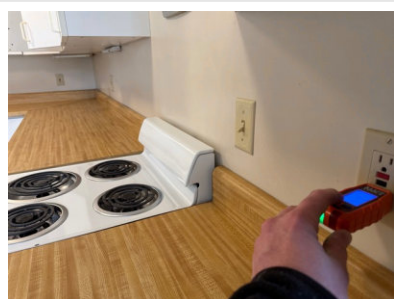
4.3.B Item 1 (Picture)

**DIDN'T TRIP:** One, or more, of the GFCI outlets servicing the counter area were tested with an outlet tester and did not trip. Failure to trip is a safety concern and a repair or replacement of the outlets may be needed. I recommend that a licensed and insured electrician investigate the outlets in the kitchen further and repair as needed. Execute or obtain estimates for needed actions prior to closing.

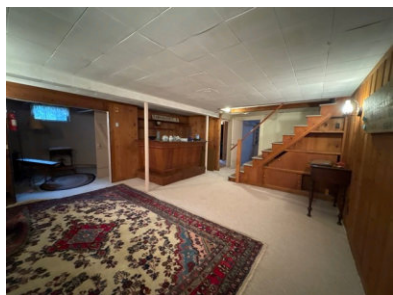
5.0.A Item 1 (Picture)

(1) **ASBESTOS CONCERN:** During the inspection of the basement, it was observed that ceiling tiles were installed. These tiles appeared to pre-date asbestos regulation so materials in the tiles may contain asbestos. Having these tiles tested for it's presence is recommended prior to closing. If determined to be present it would be prudent to obtain estimates for removal.

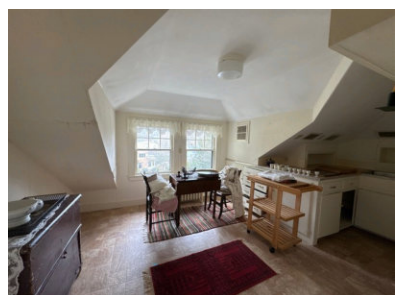
5.0.A Item 6 (Picture)

(2) **DRY STAINS:** Generally, the ceiling surfaces in the primary residence (above ground) were found to be in serviceable condition. Minor dry staining was observed in the upstairs "kitchen". These stains did not appear to be wet or active. Treat and repaint as needed.

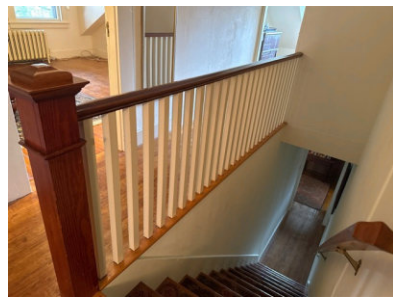
5.4.A Item 1 (Picture)

(1) **OLD STAIRS = LOW GUARD RAIL:** Inspection of the guard rail system above the staircase revealed evidence of a very low elevation from the floor height to the top of the railing. (See pictures) While a low elevation of the guard rail is typical for a house of this age, and no repair is required; the low elevation of the rail is a safety hazard as compared to a modern rail system meeting the current standards. As desired, I recommend having a capable and insured carpenter or contractor evaluate and provide estimates for updating the stair rail system

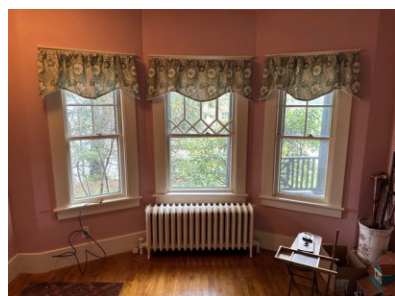
5.5.A Item 1 (Picture)

**OLD, BUT WORK:** Most of the windows in the home operated as intended. While they were single pane windows they did function as intended. That said, there are a couple areas, pictured, that are in need of minor repair such as replacing sash cords.

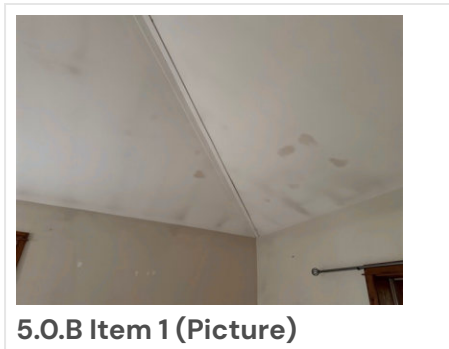
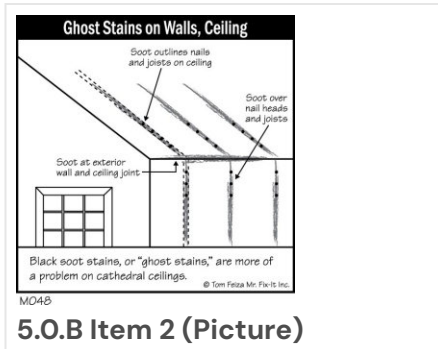
**GHOSTING:** During the inspection of the interior areas, dark staining on some portions of the ceiling surfaces was observed. The staining does not appear to be a suspicious microbial growth, rather it looks to be caused by "ghosting". Ghosting is a result of thermal bridging in the ceiling's structure. In essence the ceiling's structural members are not insulated and can allow for more air movement providing an air for dirty particles to collect. This results in black sooty stains on your ceiling that follow the patterns of your home's framing. Sometimes stains can even reveal fasteners in a ceiling because the metal is more prone to becoming a condensing surface. Typically, the amount of condensation is not enough to cause a mold or structural problem, but it does create irritating lines on your surfaces. Typically, washing and repainting is an adequate repair. [For more discussion and information on Ghosting.](#) I recommend consulting with a painting professional now to obtain estimates for this cosmetic repair.

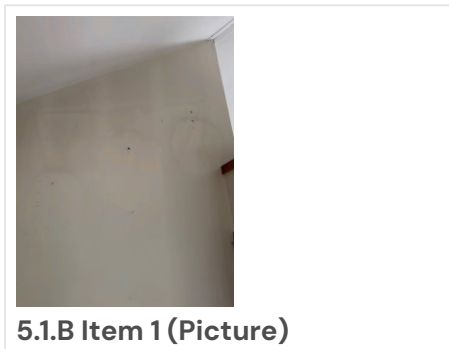
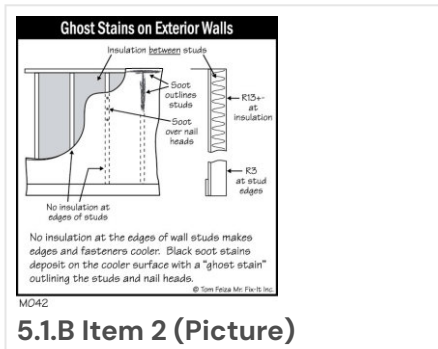
**GHOSTING:** During the inspection of the Living Room, dark staining on some portions of the wall surface was observed. The staining does not appear to be a suspicious microbial growth, rather it looks to be caused by "ghosting". Ghosting is a result of thermal bridging in the wall's structure. In essence the wall's structural members are not insulated and can allow for more air movement providing an air for dirty particles to collect. This results in black sooty stains on your walls that follow the patterns of your home's framing. Sometimes stains can even reveal fasteners in a wall because the metal is more prone to becoming a condensing surface. Typically, the amount of condensation is not enough to cause a mold or structural problem, but it does create irritating lines on your finished surfaces. Typically, washing and repainting is an adequate repair. [For more discussion and information on Ghosting.](#) I recommend consulting with a painting professional now to obtain estimates for this cosmetic repair.

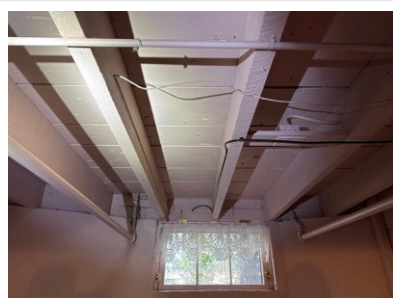
7.5 Item 1 (Picture)

**NO INSULATION:** The floor system is not insulated. Heat loss can occur more on this home than one that is properly insulated. I recommend having an insulation professional make recommendations on completely and adequately insulating the floor system. Secure costs prior to closing.

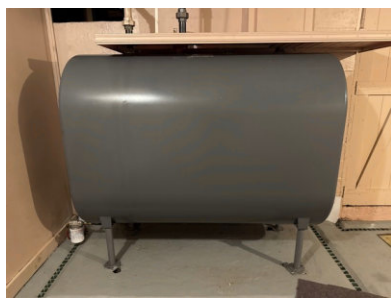
8.4 Item 5 (Picture)

(3) **OIL TANK:** The oil tank appeared in good condition during the inspection. The oil tank should be inspected annually by a fuel supplier or heating equipment technician. As the tank becomes older having the walls "gauged" annually is advisable. At the time of inspection, no immediate action is called for.

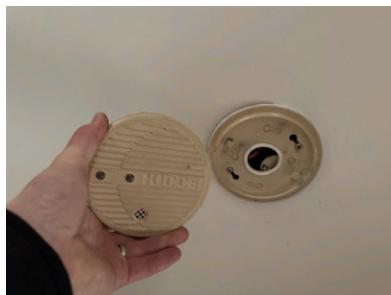
9.7 Item 1 (Picture)

(1) **SAFETY FIRST:** I recommend replacing the batteries in the smoke detectors and/or the replacing the units themselves. The installed units in the apartment were not tested during the inspection. A smoke detector has a reliable working life of 10 years. At the time of inspection, the unit in the apartment appeared passed their scheduled obsolescence of 10 years. The units should be replaced for safety. When the units are replaced, I recommend consulting with a licensed and insured electrician or the local fire safety official as to the best safety device for specific areas.

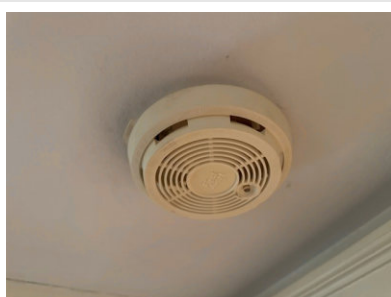
9.7 Item 3 (Picture)

(2) **SAFETY FIRST:** As is unfortunately typical with a house of this age, there are no hardwired or interconnected smoke detectors present in the primary home. The current homeowners had installed battery operated detectors, which is a good step. I highly encourage the client to have hardwired smoke detectors installed, per the local jurisdiction's Safety standards, in every bedroom and level. A licensed and insured electrician can perform this necessary safety upgrade. If new detectors are purchased, I highly recommend installing combination smoke / CO detectors. Many jurisdictions are allowing combination Smoke/CO detectors with 10-Year Batteries, as long as the communicate with each other. Check with your local building authority to confirm.

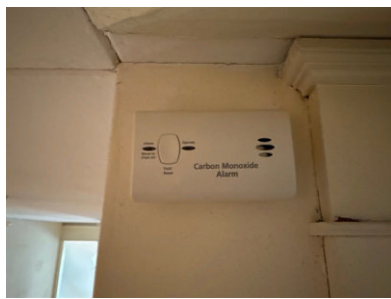
9.8 Item 1 (Picture)

**ADD CO DETECTORS:** There were no WIRED or INTERCONNECTED carbon monoxide detectors observed in the home. There were battery operated detectors. It is recommended that at least one WIRED and INTERCONNECTED detector be installed according to the manufacturer's instructions & local building authority on each floor. A capable person or electrician could help with this needed safety upgrade.

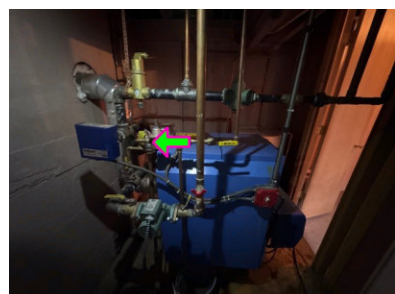
10.3 Item 7 (Picture)

(2) **BOILER DISTRIBUTION:** During the inspection, it was noted that several components of the heating system's distribution system are in need of maintenance/repair. Areas of concern are: valve and the obsolete expansion tank. I recommend a qualified and insured heating professional evaluate the entire distribution system and provide estimates for making the needed repairs prior to closing. See pictures for further details.

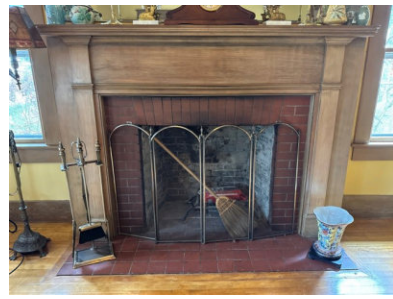
10.6 Item 2 (Picture)

was damaged and it appeared that the damper had been removed. It appeared that a pop up or tip down cap may have been installed at some point but nothing was present. Chimney appeared in need of cleaning and a Level 2 evaluation prior to closing. A certified chimney professional can perform [this needed safety evaluation](#) prior to closing or the first use.
