Inspection Report

Property Address: 347 Anderson Cove Rd Acton ME 04001

North Coast Home Inspection, LLC
Chris Ross 00551

Date: 8/18/2025	Time: 09:00 AM	Report ID: 3399
Property: 347 Anderson Cove Rd Acton ME 04001	Customer: Pam Gaya	Real Estate Professional: Chasity Cameron KELLER WILLIAMS COASTAL AND LAKES & MOUNTAINS REALTY

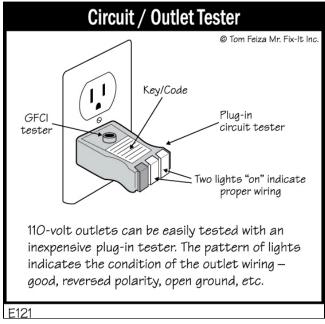
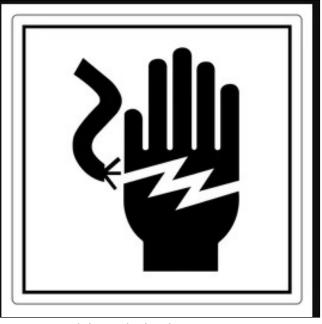
1.13 Item 1(Picture) Circuit/Outlet Tester

- Circuit/Outlet Tester
- Electrical outlet(s) in need of cover, safety hazard. Recommend installing cover.

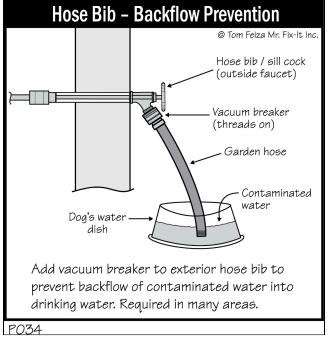
3.10 Item 2(Picture)

3.10 Hose bib(s) not equipped with anti-siphon devices, possible cross connection can occur without anti-siphon device, recommend licensed plumber installing anti-siphon device.

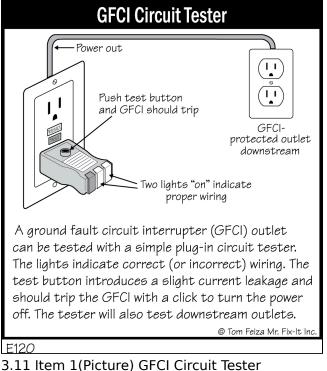
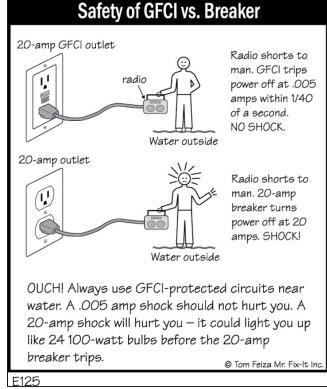
3.11 Item 2(Picture) GFCI- Shock

- Ground Fault Circuit Interrupter (GFCI), required Exterior/Garage
- Open ground is a potential safety hazard, recommend repair by a qualified electrical contractor
- Exterior receptacles are not GFCI protected, recommend replacing with GFCI receptacles. Recommend repair by a qualified electrical contractor

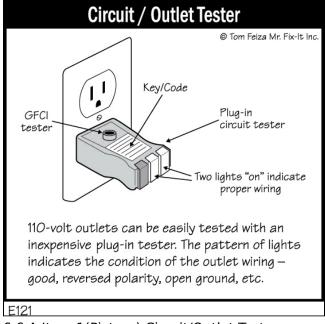
6.6.A Item 1(Picture) Circuit/Outlet Tester

- Circuit/Outlet Tester
- Open ground is a potential safety hazard, recommend repair by a qualified electrical contractor

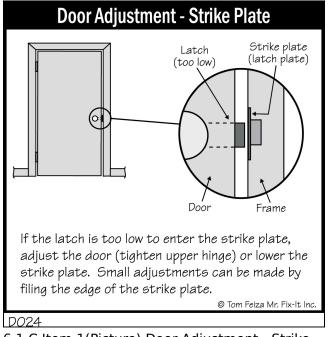
6.1.C Item 1(Picture) Door Adjustment - Strike Plate

6.1.C Entry door striker plate out of line, will not latch properly, recommend repair

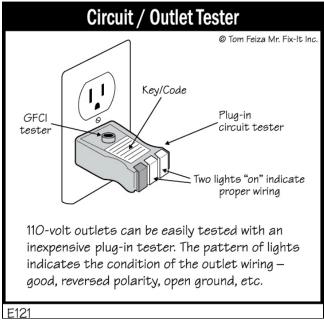
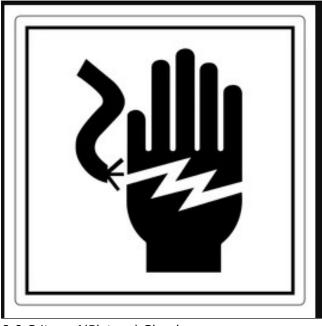
6.6.C Item 3(Picture) Circuit/Outlet Tester

- Circuit/Outlet Tester
- Open ground is a potential safety hazard, recommend repair by a qualified electrical contractor

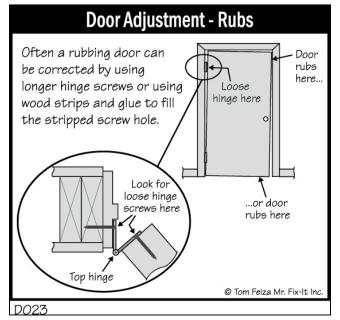
6.1.D Item 2(Picture)

6.1.D Entry door rubs on floor when opening, recommend repair

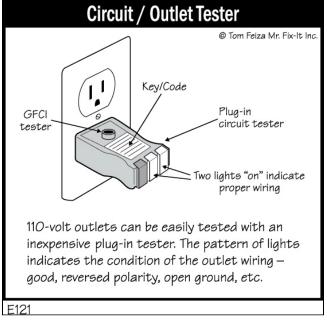
6.6.E Item 3(Picture) Circuit/Outlet Tester

- Circuit/Outlet Tester
- One "three-prong" outlet is not working. Electrical issues are considered a hazard until repaired. A qualified licensed electrical contractor should perform repairs that involve wiring.

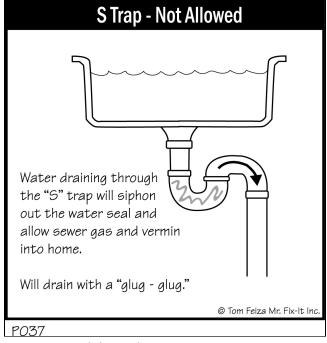
7.6.A Item 1(Picture) S Trap

7.6.A The plumbing waste line is a S trap and needs upgrade to a P trap with an auto-vent at the bath sink. This is not considered up to today's standard. A qualified licensed plumber should repair or correct as needed.

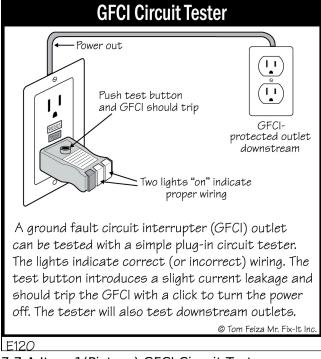
7.7.A Item 2(Picture)

- Ground Fault Circuit Interrupter (GFCI), required when outlet is located less then 6' from water source.
- There is no outlet found in bath. I recommend a duplex GFCI outlet be installed by a licensed electrical contractor.

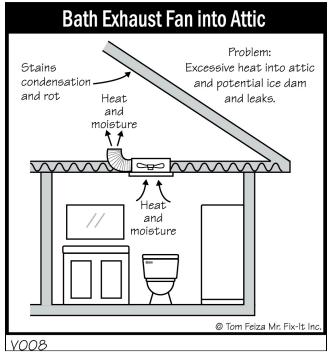
7.8.A Item 1(Picture) Bath Exhaust Fan Into Attic

7.8.A No evidence that Exhaust fan is venting to exterior, recommend proper venting to exterior by qualified contractor.

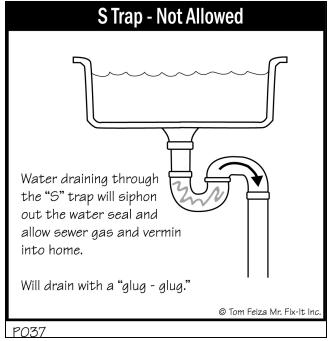
7.8.B Item 1(Picture) S Trap

7.8.B (1) The plumbing waste line is a S trap and needs upgrade to a P trap with an auto-vent at the bath sink. This is not considered up to today's standard. A qualified licensed plumber should repair or correct as needed.

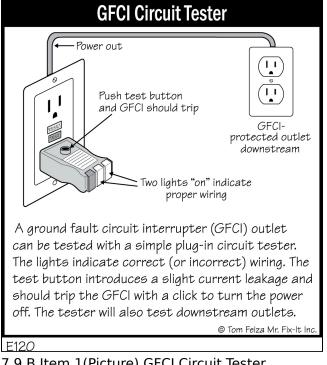
7.9.B Item 1(Picture) GFCI Circuit Tester

- Ground Fault Circuit Interrupter (GFCI), required when outlet is located less then 6' from water source.
- GFCI receptacle(s) not functioning, recommend replacing GFCI receptacles. Recommend repair by a licensed electrical contractor
- Open ground is a potential safety hazard, recommend repair by a qualified electrical contractor

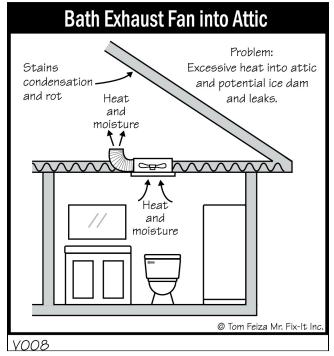
7.10.B Item 1(Picture) Bath Exhaust Fan Into Attic

7.10.B (1) No evidence that Exhaust fan is venting to exterior, recommend proper venting to exterior by qualified contractor.

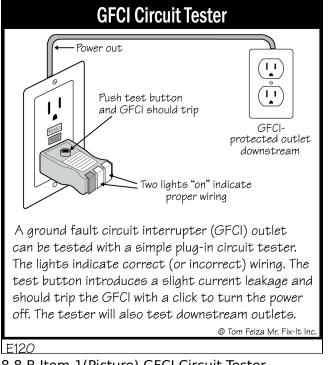
8.8.B Item 1(Picture) GFCI Circuit Tester

- Ground Fault Circuit Interrupter (GFCI), required when outlet is located less then 6' from water source.
- Not GFCI protected within 6' of water source, recommend repair by a qualified electrical contractor

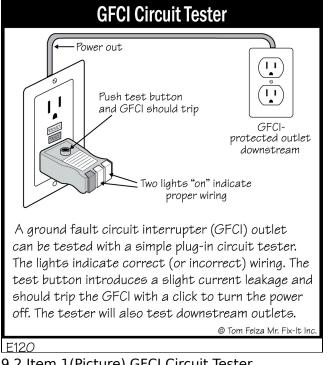
- Laundry Area receptacles are not GFCI protected, recommend replacing with GFCI receptacles. Recommend repair by a qualified electrical contractor
- GFCI receptacles are required in bathrooms, garages, crawl spaces, basements, laundry rooms and areas where a water source is present.

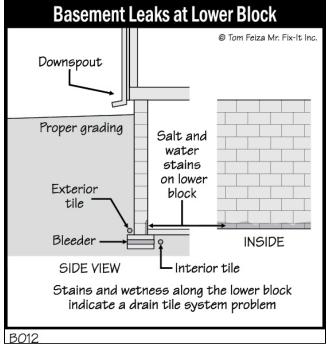
10.2 Item 1(Picture) Basement Leaks at Lower Block

10.2 (1) White efflorescence (powder substance) on block wall indicates moisture is in contact with the masonry. This does not necessarily indicate that intrusion will occur. I recommend checking the gutters and the downspout drain lines for proper operation. Also, a water proofing paint could be applied to the interior side of the block if necessary. Efflorescence is found on many homes without water intrusion occurring inside the home. But, it should alert you to the possibility that future steps may be needed.

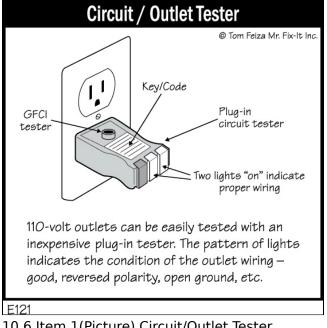
10.6 Item 1(Picture) Circuit/Outlet Tester

10.6 Circuit/Outlet Tester Electrical outlet(s) in need of cover, safety hazard. Recommend installing cover.

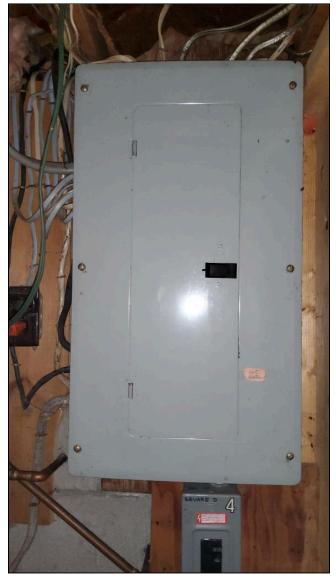
13.1 Item 3(Picture)

(2) The main panel box is located in the basement.

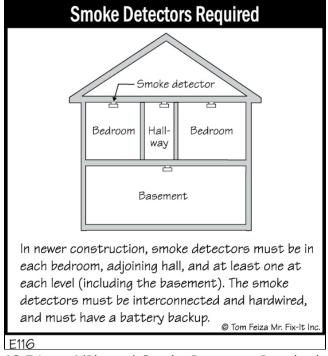
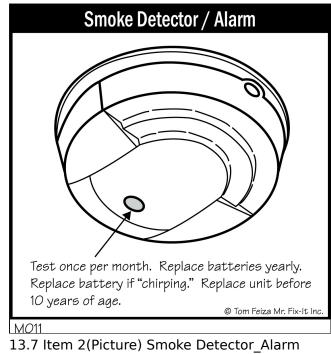
13.7 Item 1(Picture) Smoke Detectors Required

13.7 (1) Smoke Detector(s) were not tested during Inspection, recommend testing of Smoke Detector(s) prior to taking occupancy. Recommendations for location of Smoke Detectors (see diagram). Reference State and Local code requirements in your area for further details.

(2) Smoke detector(s) are missing. Without a working smoke detector in your home you have no first alert to a possible fire. A qualified person should repair or replace as needed.

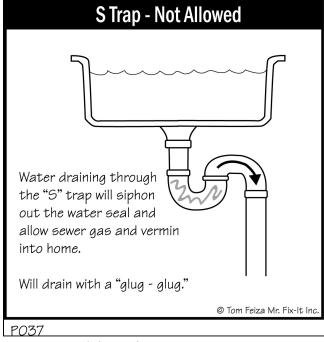
7.6.A Item 1(Picture) S Trap

The plumbing waste line is a S trap and needs upgrade to a P trap with an auto-vent at the bath sink. This is not considered up to today's standard. A qualified licensed plumber should repair or correct as needed.

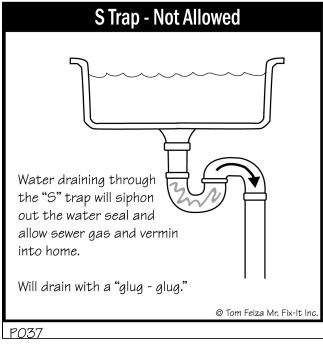
7.8.B Item 1(Picture) S Trap

(1) The plumbing waste line is a S trap and needs upgrade to a P trap with an auto-vent at the bath sink. This is not considered up to today's standard. A qualified licensed plumber should repair or correct as needed.
