## Inspection Report

### The Estate of Janet H. Gourley

52 Whipple Road  
Kittery, Maine 03904

### DBC Home Inspections

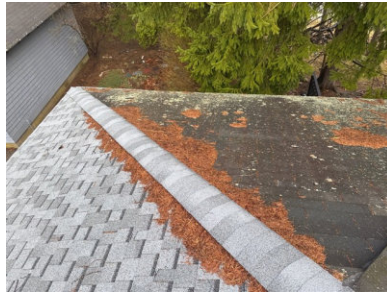
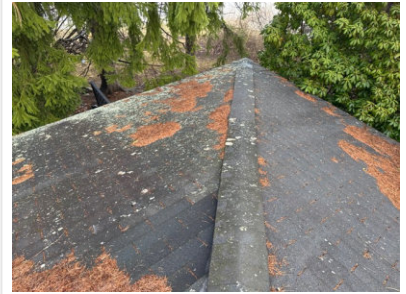
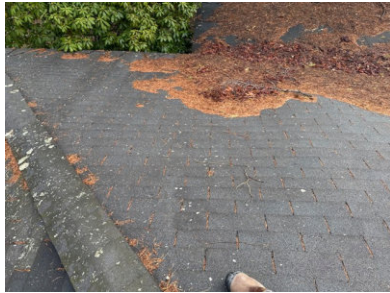
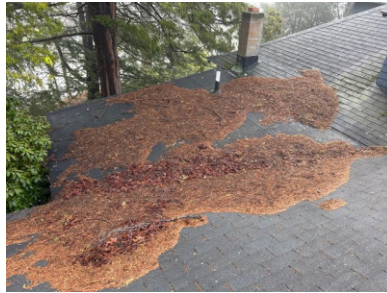
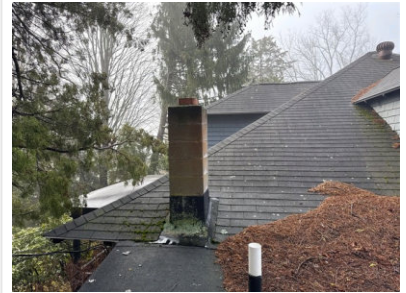
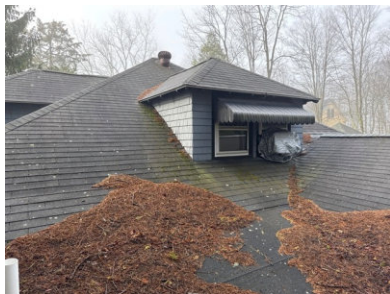
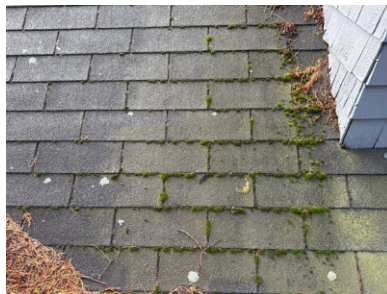
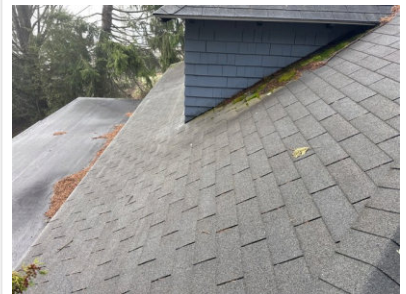
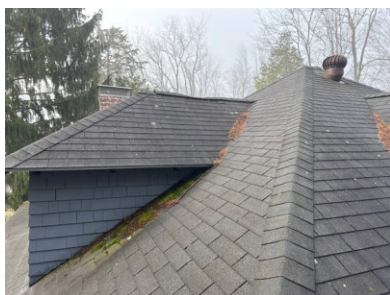
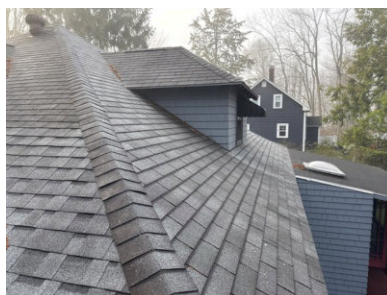
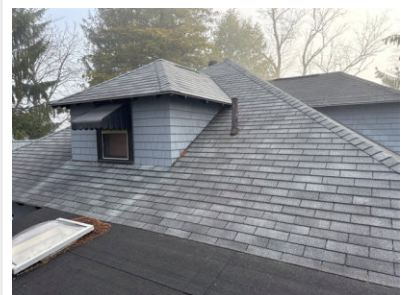
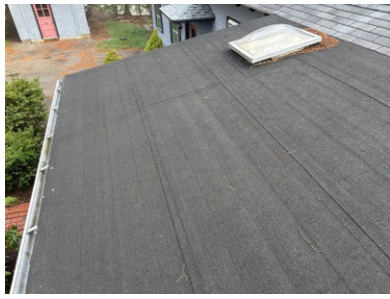
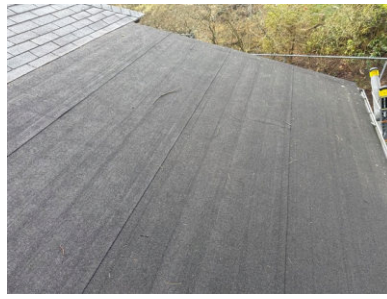
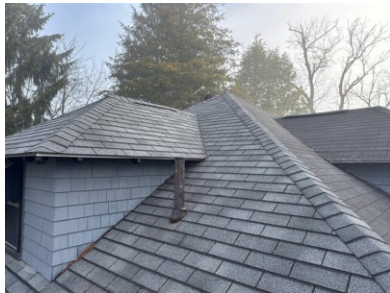
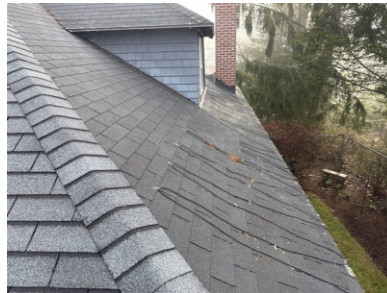
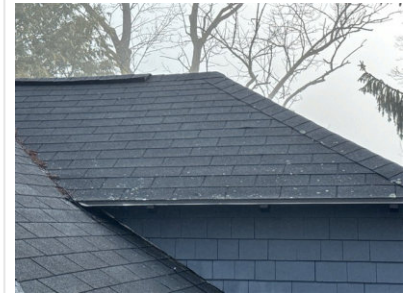
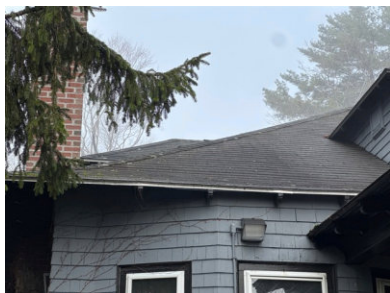
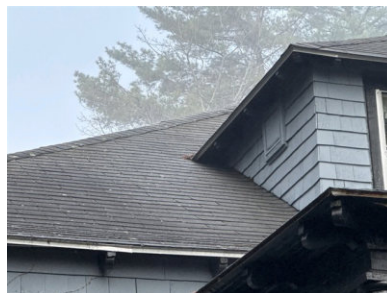
A MIXED BAG OF TYPES AND AGES: The inspected property had three different types of asphalt roofing installed. Each type of roofing material also appeared to be a different age and displayed different characteristics and conditions.

- Some portions of the house have low slope or flat roofing. These areas have a rolled asphalt roofing material. This material typically has a reliable service life of approximately 15 years. Evidence of wear and minor cracking was observed in multiple areas. These characteristics would indicate that the roofing material is around 15 years old.

- The bulk of the roof structure has a 3-Tab asphalt roof roofing shingle installed. Similar to the rolled roofing material, this style of shingle typically has reliable service life of approximately 15 to 20 years. Entirely depends on the quality of the initial shingle and the environment in which it is installed. At the time of inspection, the shingles generally looked to still be in serviceable condition, but there was evidence of age as well as organic buildup and material in multiple areas. Removal of any moss or other organics is highly recommended. Given the expected age of the shingles, age replacement will likely become necessary in the near future.

- A small portion of the roof appears to have an architectural style shingle that may have recently been installed. This roofing material typically has a reliable service life of approximately 25 to 30 years. These shingles appeared young and in good condition.

Generally, there were no indications of active leaking, observed on the interior of the home. That's it, given the apparent age of most of the roof covering, preparing for replacement is highly recommended. It would

be prudent to have a roofing professional, evaluate the roof area now and provide the client with estimates for replacement. Utilizing architectural style shingles would likely be recommended in pitched areas.

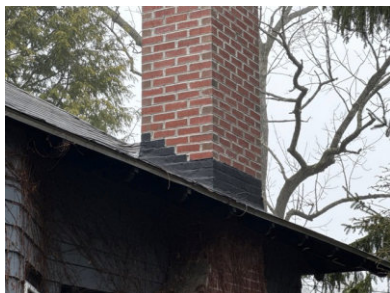
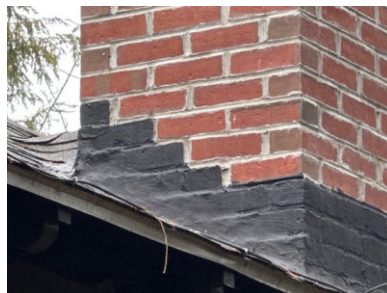
**JUST TAR:** During the visual inspection of the chimney there was no visible metal flashing. Instead it had been tarred with a roofing mastic, or equivalent sealant. This material will have a shorter reliable service life and the installation of proper metal flashing is highly recommended. Consult with a capable mason for further information and pricing.

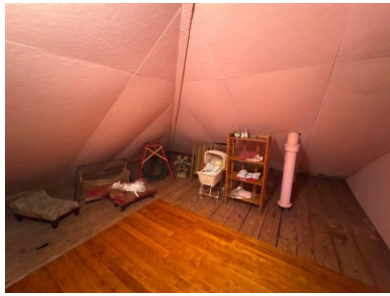
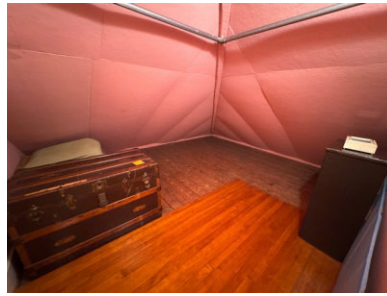
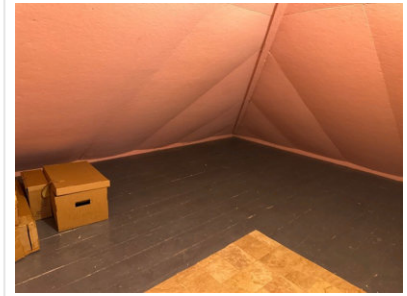
**NOT VISIBLE:** All attic areas were either concealed or finished for living space. No portion of the roof structure was visible for interior evaluation.

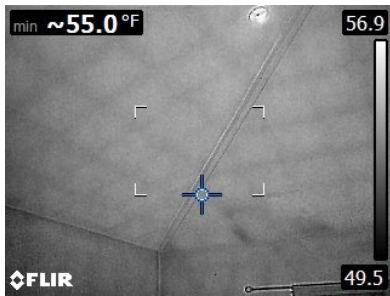
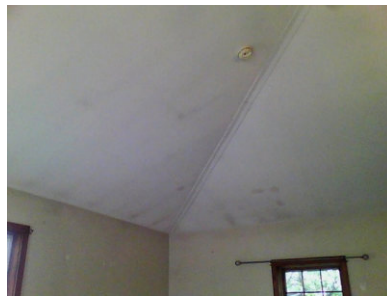
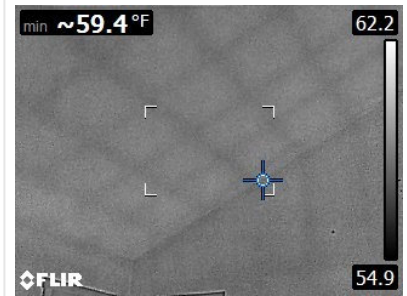
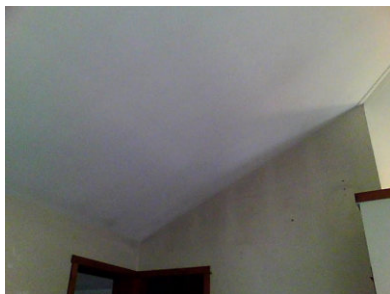
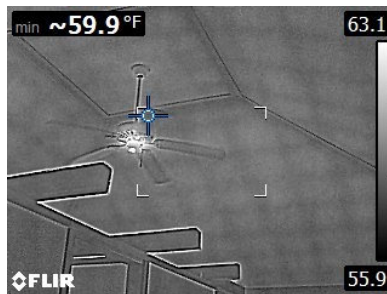
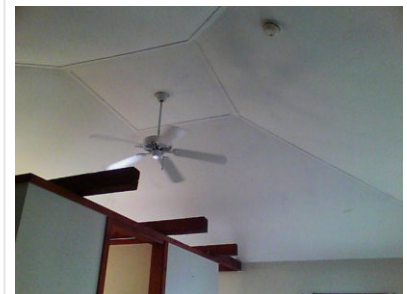
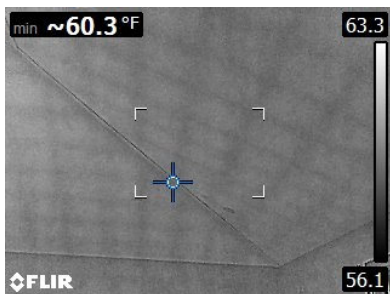
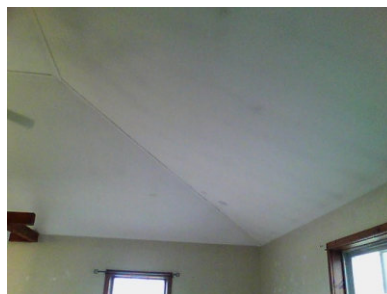
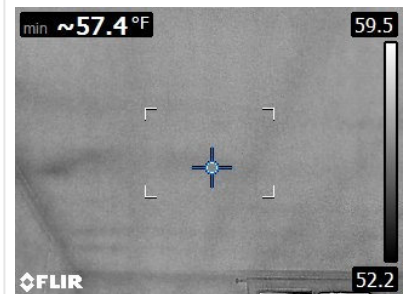
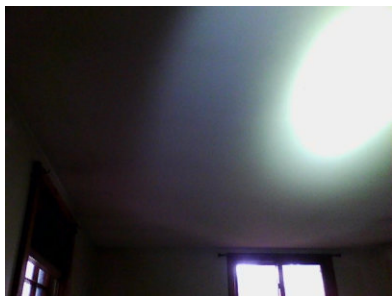
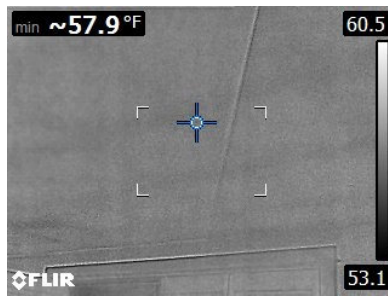
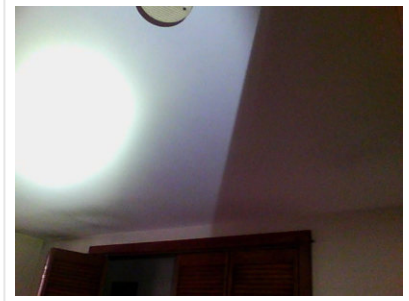
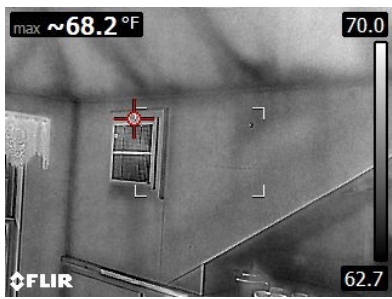
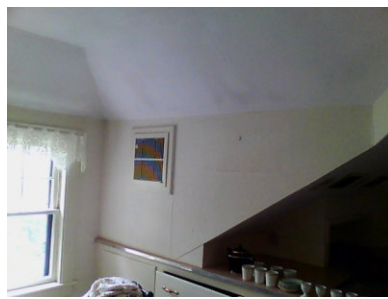
**NO ATTIC:** Due to there being no accessible attic space this component was not visually inspected. The ceiling areas were scanned using a Flir E6 Thermal Camera, the images depicted no significant abnormalities indicating gaps in the insulation. This could indicate that the ceiling structure is completely insulated; but, without access it can not be confirmed and the amount of insulation could not be calculated.

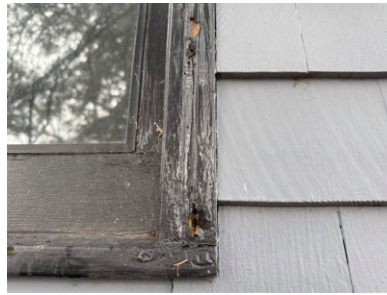
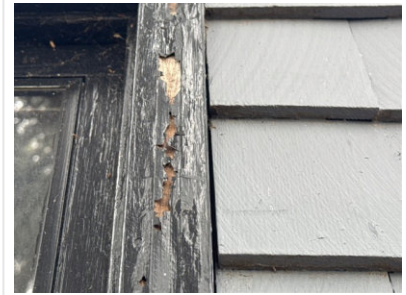
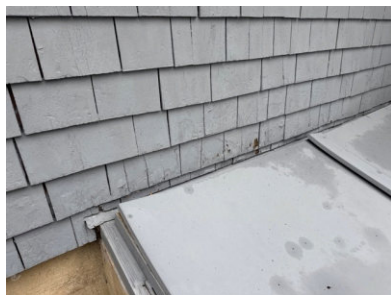
(1) **TRIM TLC:** As is typical of most homes of this era, the trim is painted wood. To ensure a continued reliable life of the wood material, the paint coating on the trim should be maintained and sections where peeling and popping occurs should be sealed promptly to reduce the chance of rot. In any instance where wooden trim needs to be replaced because of rot or decay, I highly encourage replacing the wooden material with solid PVC trim (such as Kleer or Azeck). Once it is painted it nearly indistinguishable from

wood. Additionally, many of the classic exterior architectural details have been reproduced out of the same PVC material. During the inspection, it was noted that most of the older trim appeared in serviceable condition but some of the more modern trim around the apartments windows was displaying signs of decay and calls for replacement. See pictures for further details and obtain estimates for needed repairs prior to closing.

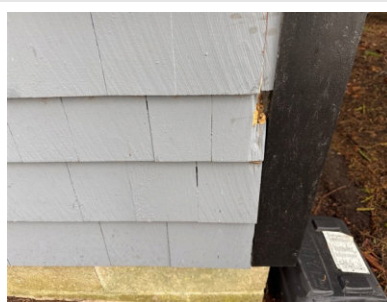
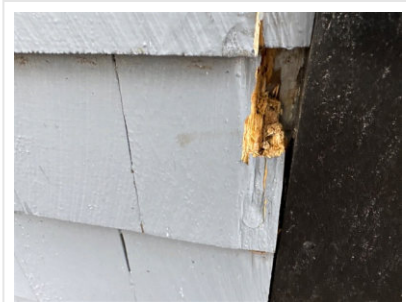
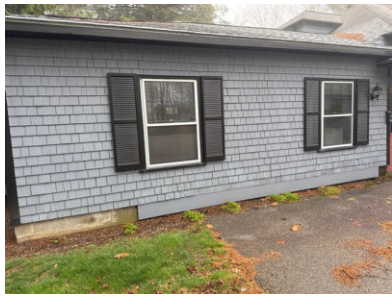
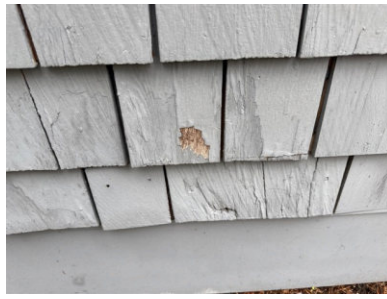
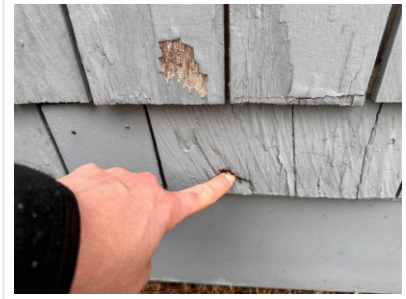
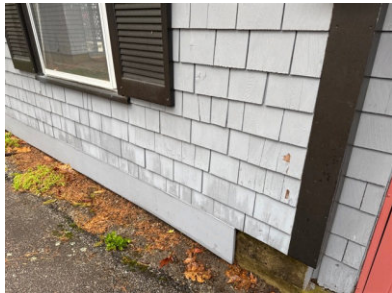
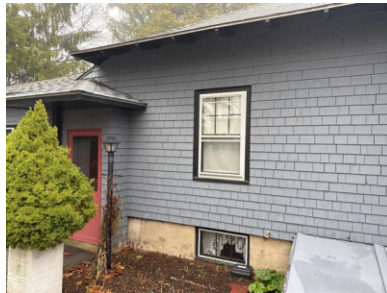
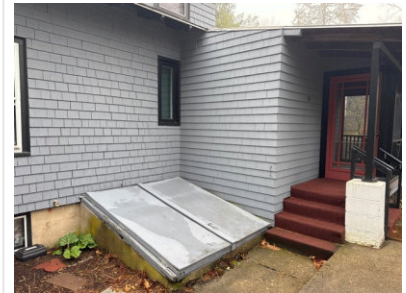
(2) **PAINTED SHINGLES:** The home's shingle siding appeared to have been painted. As with many homes with painted siding, flaking paint will be a concern in the future. As older original layers of paint begin to release they will flake the new layers of paint off. Maintaining a complete paint coverage over all wooden siding materials is imperative in keeping the exterior of the house healthy. Over time some shingles, especially south facing areas, will show signs of cupping and cracking. Monitor these areas closely and repair any shingles that fail or fall apart.

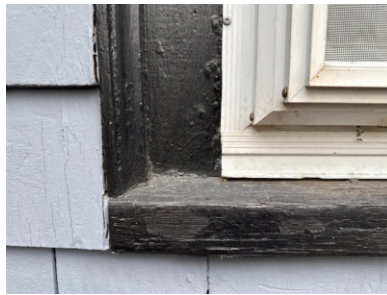
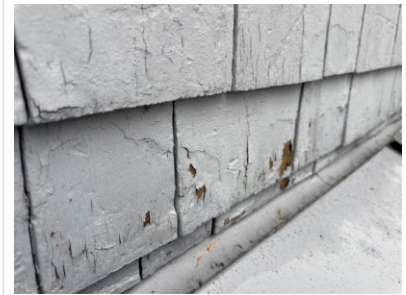
(3) **LEAD PAINT CAUTION:** As is typical with a home this age, the siding and trim are showing signs of age and multiple layers of paint. Given the age of the home, the chances of there being a layer of lead based paint on the exterior is highly likely. Further evaluation and testing maybe prudent and desired to determine the presence of lead. Generally, the siding and trim was in fair condition with no immediate required. That said, like with every old home maintenance will be a constant. If lead is determined to be present, certain protocols will be required for future maintenance and repairs. It is strongly recommended to have a follow up evaluation with a properly credentialed [Lead Risk Assessor](#) prior to closing.

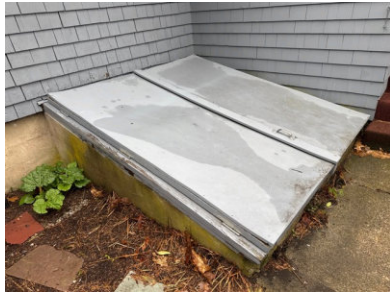
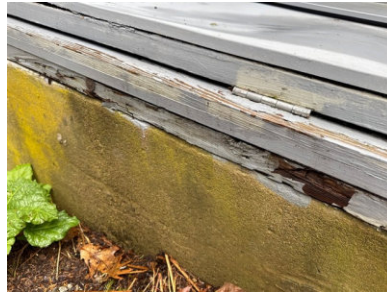
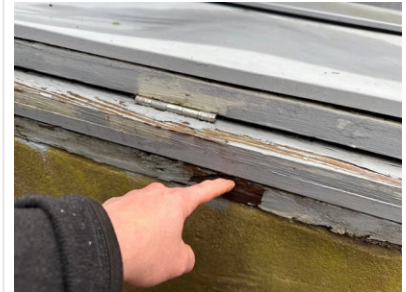
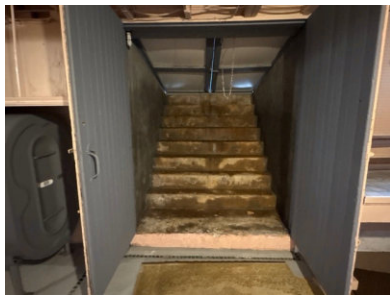
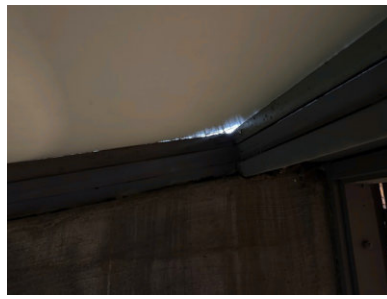
(2) **BUTTON UP:** The bulkhead door provides access to the basement from the exterior. While these doors are very convenient they can be a source of heat loss. Unfortunately, there were several large air gaps that will allow cold air and pests to enter freely. I recommend a capable carpenter properly finish these areas so that there is a good air seal and adequate deterrents for pests and vermin.

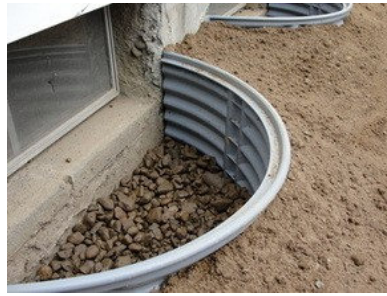
2.2 Item 2 (Picture)

(1) **AT GRADE:** At the time of inspection, the home had one, or more, grade level basement windows which were at, or close to, grade. The condition of the windows appeared good; but, as the windows are at grade there is room for improvement. I recommend digging out the area 6-10" or so and installing a simple window

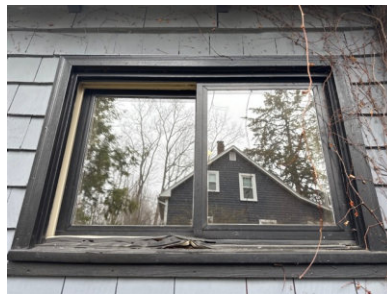
2.2 Item 4 (Picture)

(2) **DAMAGED WINDOW:** The pictured window on the south side of the home appears to have components, which have been melted. As one can see in the image, it is directly across from another house. Reflected light may have been the cause. Regardless of the cause, the damage could result in water penetration so a repair is recommended. Follow up with a capable contractor and repair is needed.

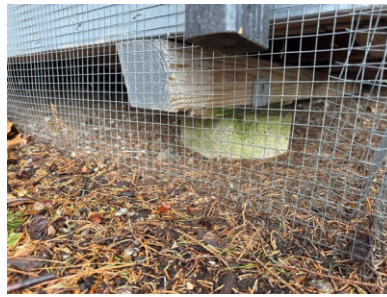
2.3 Item 2 (Picture)

not possible at this time. Monitor and repair as needed.

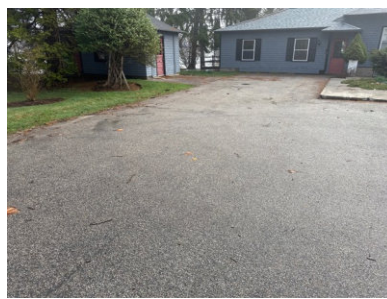
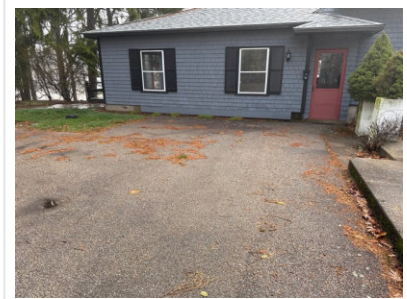
**OBSERVED CONDITIONS:** The condition of the driveway was good. There was minimal cracking, no weeds growing through the asphalt. Having any cracks tarred and the entire driveway sealed next spring would be a great maintenance task.

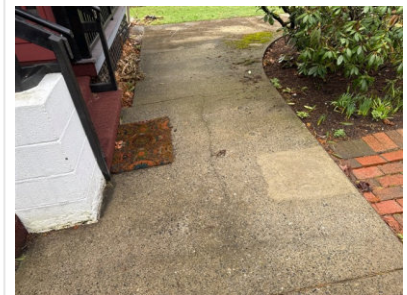
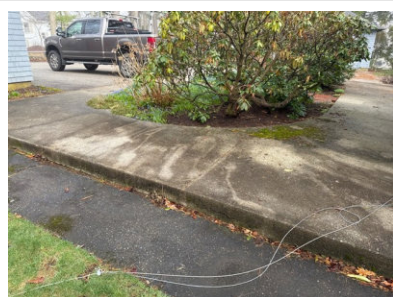
(2) **SIDEALKS:** Sidewalks around the driveway garden appeared in serviceable condition. Evidence of minor settling was noted but there did not appear to be any calls for immediate action.

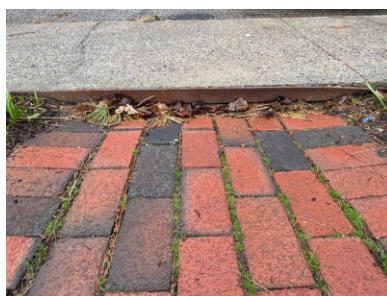
2.5 Item 9 (Picture)

(3) **BRICK PATH:** The brick path across the garden appears to have settled since installation and trip hazards are present. I recommend that a landscape professional evaluate and provide estimates for resetting the path.

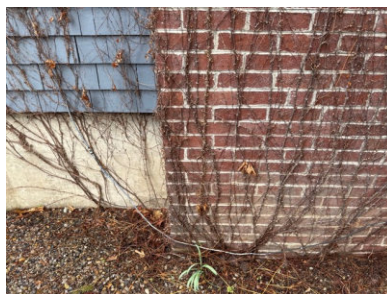
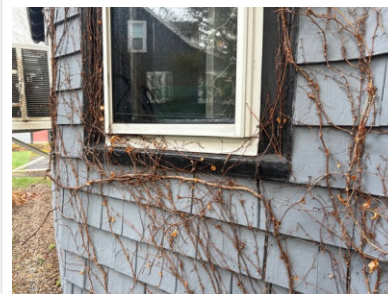
(4) **VEGETATION:** Having vegetation growing on or too close to the home is not recommended. It can allow insects and vermin easy access to the home as well as cause significant rot. I would recommend vigilant pruning, cutting back and possibly removing the offending vegetation around the home.

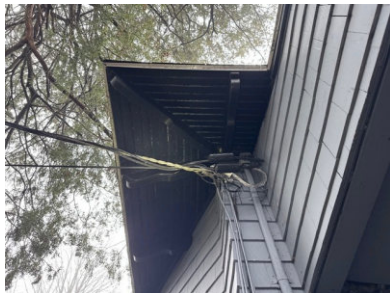
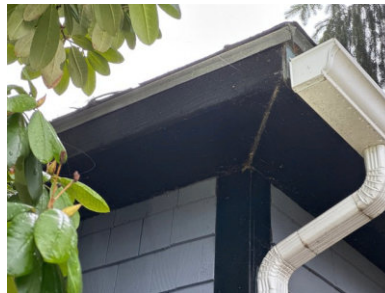
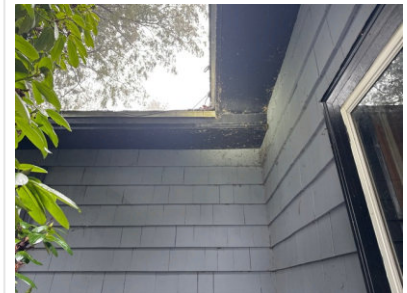
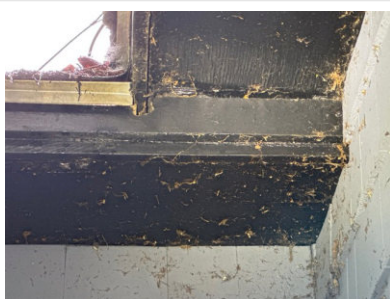
**MINOR REPAIR:** Generally, the soffits around the perimeter of the roof appeared in good condition. The exposed roof line and rafter tail detail is a primary characteristic of this style Home. These areas will need periodic painting and maintenance. Noted at the junction between the roof line of the apartment and the main house, a small hole was visible. Appears to have been created by a small pest. Recommend it be repaired and sealed.

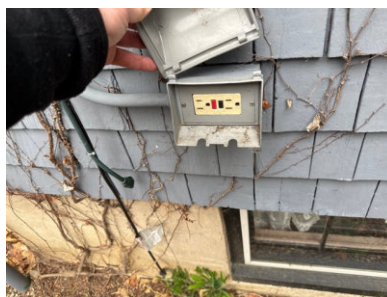
2.8 Item 2 (Picture)

**LOOSE PLATE:** The pictured outlet, on the side of the home, has a loose cover plate and needs repair. This issue should be repaired by a capable person or a licensed and insured electrician.

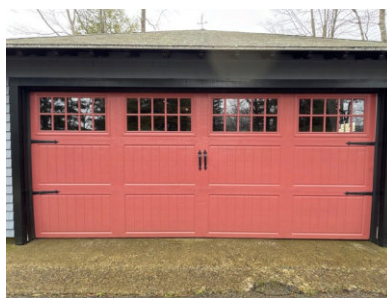
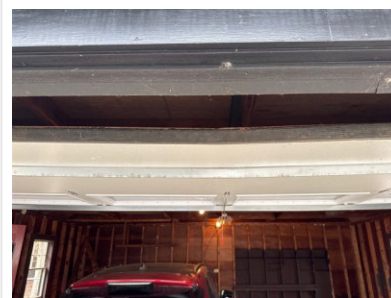
**DENTS & DINGS:** The installed garage door did have some cosmetic dents and dings but they do not effect the door's operation. Repair as desired.

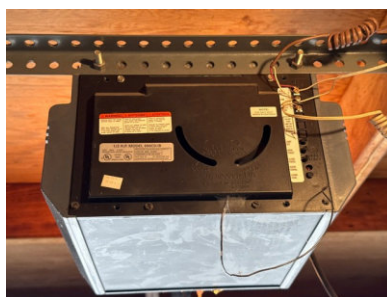
3.5 Item 2 (Picture)

**SAFETY ISSUE:** The garage door did not reverse when met with resistance. There were door sensors installed that did work. I would recommend a capable person or garage door professional adjust the operators setting to reverse under less resistance.

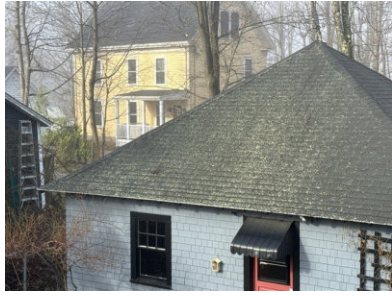
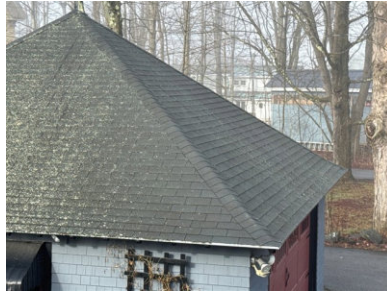
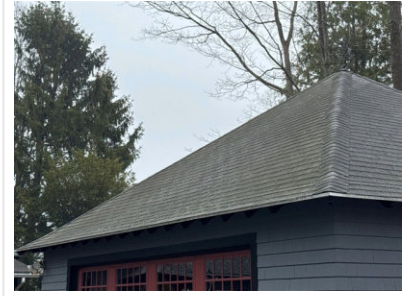
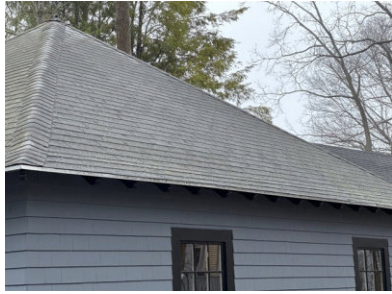
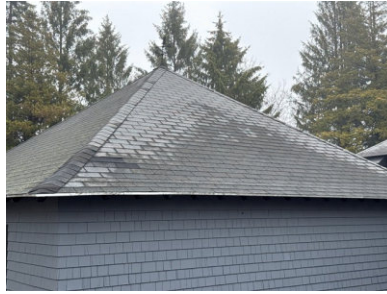
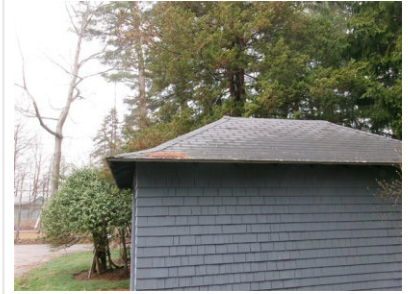
**ROOF:** The garage roof shingles appeared to be the same material and age of the main house. No immediate action is required.

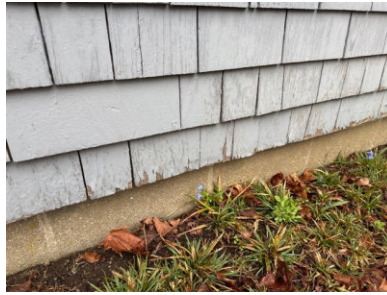
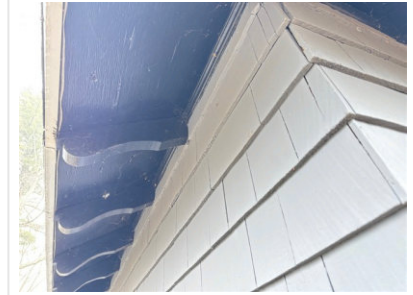
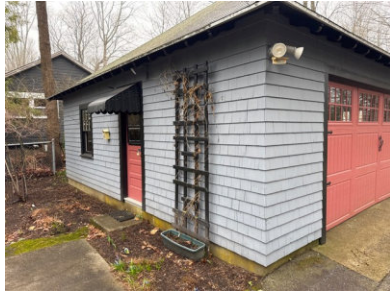
**PAINTED SIDING:** As with every old structure the trim and siding is painted wood. To ensure a continued reliable life the paint job of the trim & siding should be maintained and sections where peeling and popping occurs should be sealed promptly to reduce the chance of rot. Overtime components of the trim will need to be replaced, when that time comes I encourage you to replace the wood rot with solid PVC (will not rot). The siding material may develop areas of rot over time as well. Areas of siding that are showing signs of rot should be treated promptly so that the rot does not spread to structure. Being vigilant about siding maintenance can lead to a long reliable life for the exterior of a home. The exterior appeared in serviceable condition.. Monitor and repair as needed.

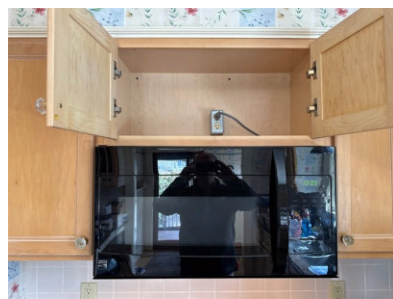
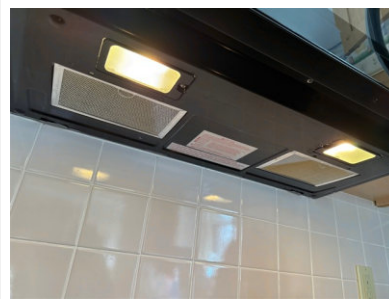
**MICRO-HOOD:** The exhaust hood for the cooking area is a feature of the built in microwave. It was tested and appeared to work as intended. It was a recirculating type of exhaust fan which just filters the air from the stove top. If any major kitchen remodeling or if this unit fails to work I would suggest installing an exhaust fan that is ducted to the outside. The installed fan would be able to be ducted to the outside, as well, if desired. This would be a great upgrade to the kitchen. Additionally, the grease filters on the underneath of the unit will need to be cleaned or replaced periodically.

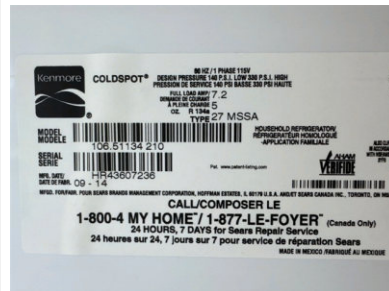
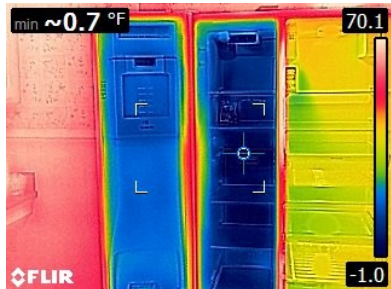
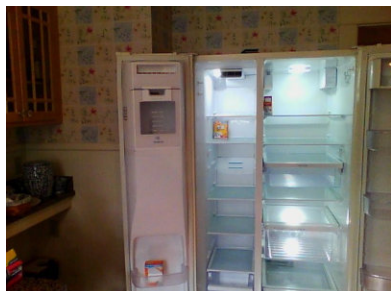
**REFRIGERATOR:** This appliance was inspected and in typical operation during the inspection. During the inspection, it was noted that the built-in ice maker was not in use. I suggest insuring that the unit is fully operational and in use for the pre-closing walkthrough of the home.

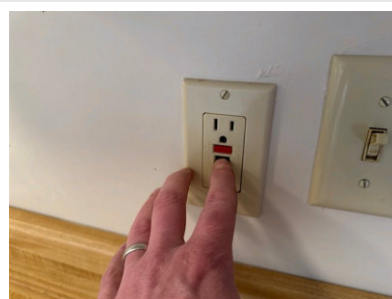
4.3.B Item 2 (Picture)

**DIDN'T TRIP:** One, or more, of the GFCI outlets servicing the counter area were tested with an outlet tester and did not trip. Failure to trip is a safety concern and a repair or replacement of the outlets may be needed. I recommend that a licensed and insured electrician investigate the outlets in the kitchen further and repair as needed. Execute or obtain estimates for needed actions prior to closing.

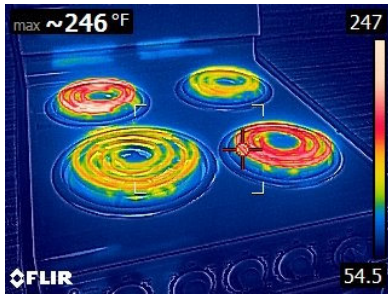
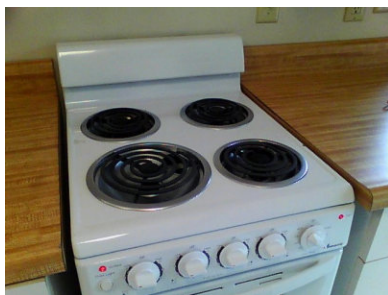
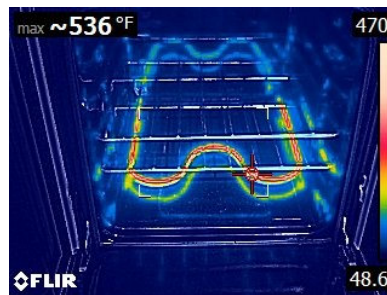
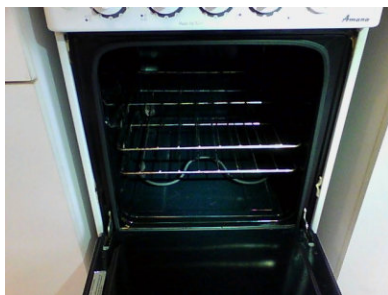
**THE RED LIGHT:** During the evaluation of the apartment, the electric oven was found to have no anti-tipped device installed and had a red light indicating that the oven was on... Even though it wasn't. There appears to be an issue with this appliance. I recommend that a capable, appliance, professional evaluate, and repair as needed.

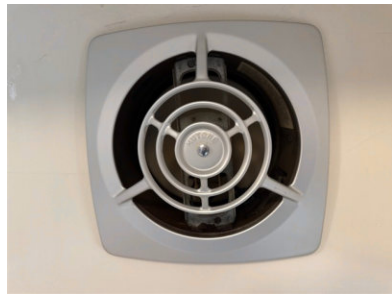
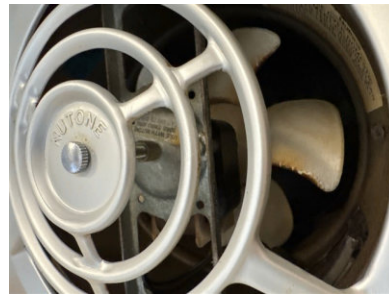
**OLD SCHOOL:** The installed cooking exhaust fan in an older style which is basically a fan built in to the wall. While it can be very effective, much more effective than a recirculating type fan, it offers very little in the way of safety. Upgrading, or modernizing, the vent fan for the kitchen may be desired. If desired, I

recommend discussing options with an insured electrician or general contractor.

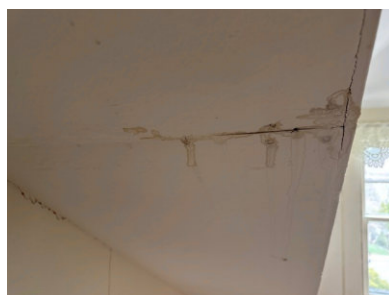
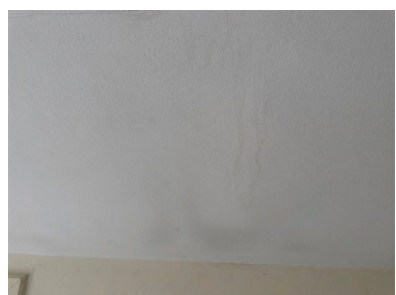
(2) **DRY STAINS:** Generally, the ceiling surfaces in the primary residence (above ground) were found to be in serviceable condition. Minor dry staining was observed in the upstairs "kitchen". These stains did not appear to be wet or active. Treat and repaint as needed.

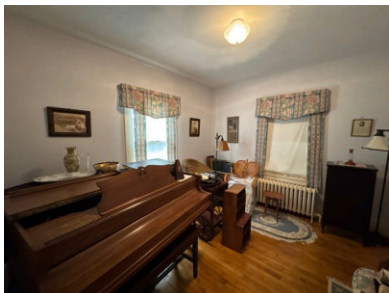
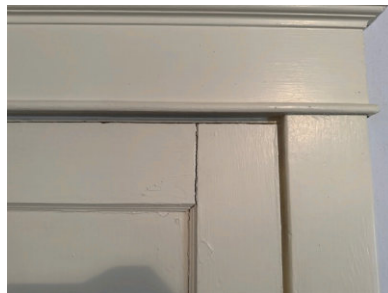
**MISC MINOR THINGS:** Generally, the doors in the primary residence were found to be in serviceable condition. Several doors were found to be in need of minor adjustment or repair. Items such as securing door latches, minor planing to reduce friction when closing and other items that a capable homeowner or insured professional can address as needed.

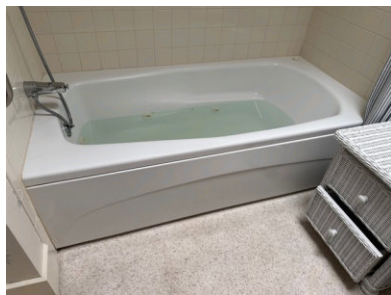
6.2.A Item 1 (Picture)

**JETTED TUB:** The jetted tub in the downstairs bath was filled and operated. It appeared to operate during testing.

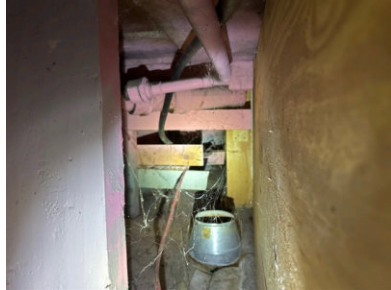
8.0 Item 1 (Picture)

**SCOPE THE MAIN LINE:** This home appears to be attached to a public sewer system. The main waste pipe from the point of exit from the home out to the main sewer is typically the responsibility of the home

owner. Given the inability for evaluation a follow up inspection with a drain scoping company is recommended. Over time waste pipes can become constricted with build up, low spots can develop, tree roots can invade and pipes can break. Having a professional drain scoping is the only way to fully determine the condition of the system. While I observed no indications that flow was obstructed during the inspection, having the line scoped is strongly recommended prior to closing. Some plumbing professionals and many "roto-routers" and/or septic inspection companies have equipment to scope and inspect the otherwise concealed piping.

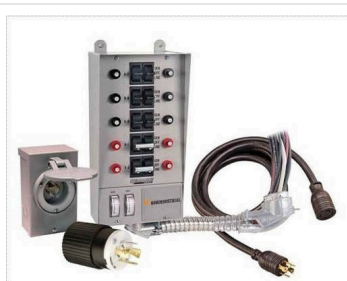
9.9 Item 1 (Picture)

**NO GENERATOR:** The home was not equipped or wired for generator. If you choose to have one installed, it should be installed by a licensed and insured electrician. A manual transfer switch, I feel, is the most cost effective and safe option for both the home and line workers.

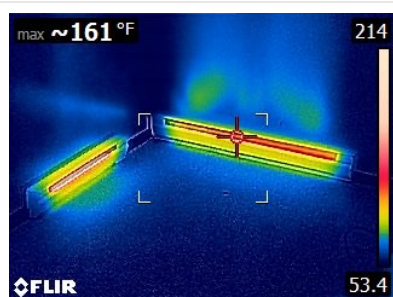
10.0 Item 9 (Picture)

(3) **ELECTRIC BASEBOARD:** The home was equipped with electric baseboard heat in the apartment and the primary bathroom. The units work as intended. The beautiful part about an electric system is that each room is its own zone and has its own thermostat for control. Each area was tested and appeared to function as intended. That said, the units would benefit from a deep cleaning.

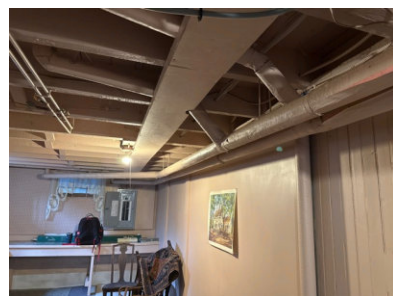
10.3 Item 1 (Picture)

- (1) **POSSIBLE ASBESTOS WRAP:** Several sections of the heating distribution pipes are wrapped with what appears to be asbestos insulation wrap. Even though the wrap appeared in good NON-friable condition, its removal is recommended. Asbestos wrap insulation can be a real health risk if not properly contained. Removal of the asbestos must be done in accordance with state law. I would recommend consulting an asbestos specialist about the pipe wrap prior to closing.

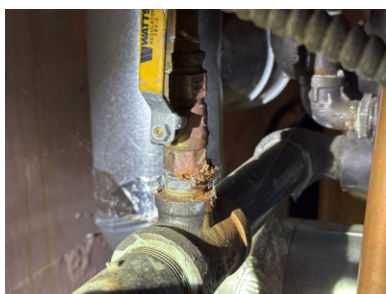
10.3 Item 8 (Picture)

(2) **BOILER DISTRIBUTION:** During the inspection, it was noted that several components of the heating system's distribution system are in need of maintenance/repair. Areas of concern are: valve and the obsolete expansion tank. I recommend a qualified and insured heating professional evaluate the entire distribution system and provide estimates for making the needed repairs prior to closing. See pictures for further details.

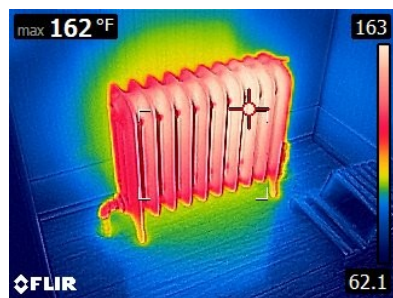
10.4 Item 1 (Picture)

**RADIATORS:** I scanned all the radiators with a Flir E6 Thermal Camera. Images depicted that heat was present and the radiators appear to be operable. Maintain as needed.

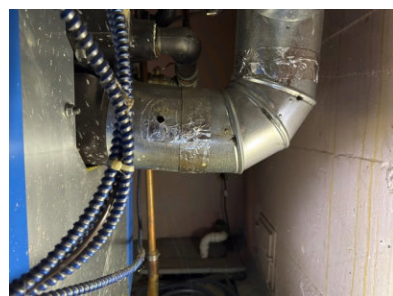
10.5 Item 2 (Picture)

**DOWNWARD DOESN'T DRAFT:** During the inspection, it was noted that the flue pipe for the heating appliance exhaust was pitched down. Flue pipes should always be pitched up so that natural flow can help assist the draft of exhausting flue gases. I recommend a capable and insured heating professional evaluate and provide estimates for repairs prior to closing.

**BUILD UP:** During the inspection of the visible heating flue pipe, there were displayed signs of build up around one, or more, of the connection/seams of the flue duct as well as at the chimney. This type of build up can be the result of unvented flue gases condensing and leaking. Unvented flue gases can be a safety concern and health hazard to the home's inhabitants. I recommend that a HV/AC/Plumbing professional evaluate the exhaust system and insure that there is adequate draft and exhaust. Further evaluation by a certified chimney expert is also recommended. Follow up to confirm proper operation prior to closing.

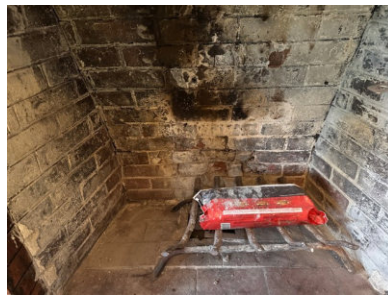
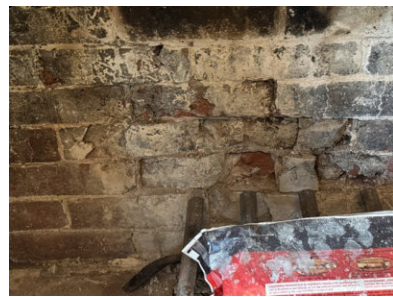
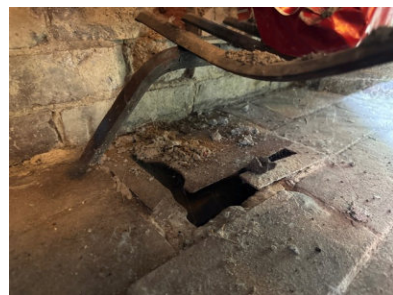
(2) **FIREPLACE:** The fireplace in the living room appears to be in need of repairs. Masonry in the firebox

was damaged and it appeared that the damper had been removed. It appeared that a pop up or tip down cap may have been installed at some point but nothing was present. Chimney appeared in need of cleaning and a Level 2 evaluation prior to closing. A certified chimney professional can perform [this needed safety evaluation](#) prior to closing or the first use.

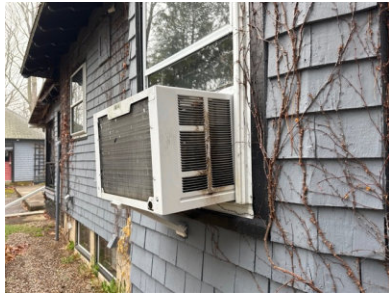
10.8 Item 1 (Picture)

**NO A/C:** There is no central air conditioning currently installed in this home. This is for your information.
